### Balcony Collapse Incident

Reference: 1713-1715 Broad Street - Deck Collapse Investigation

The following report presents our findings from the structural investigation of the collapse of the rear decks at 1713-1715 Broad Street in Hartford, Connecticut on September 10, 2016.

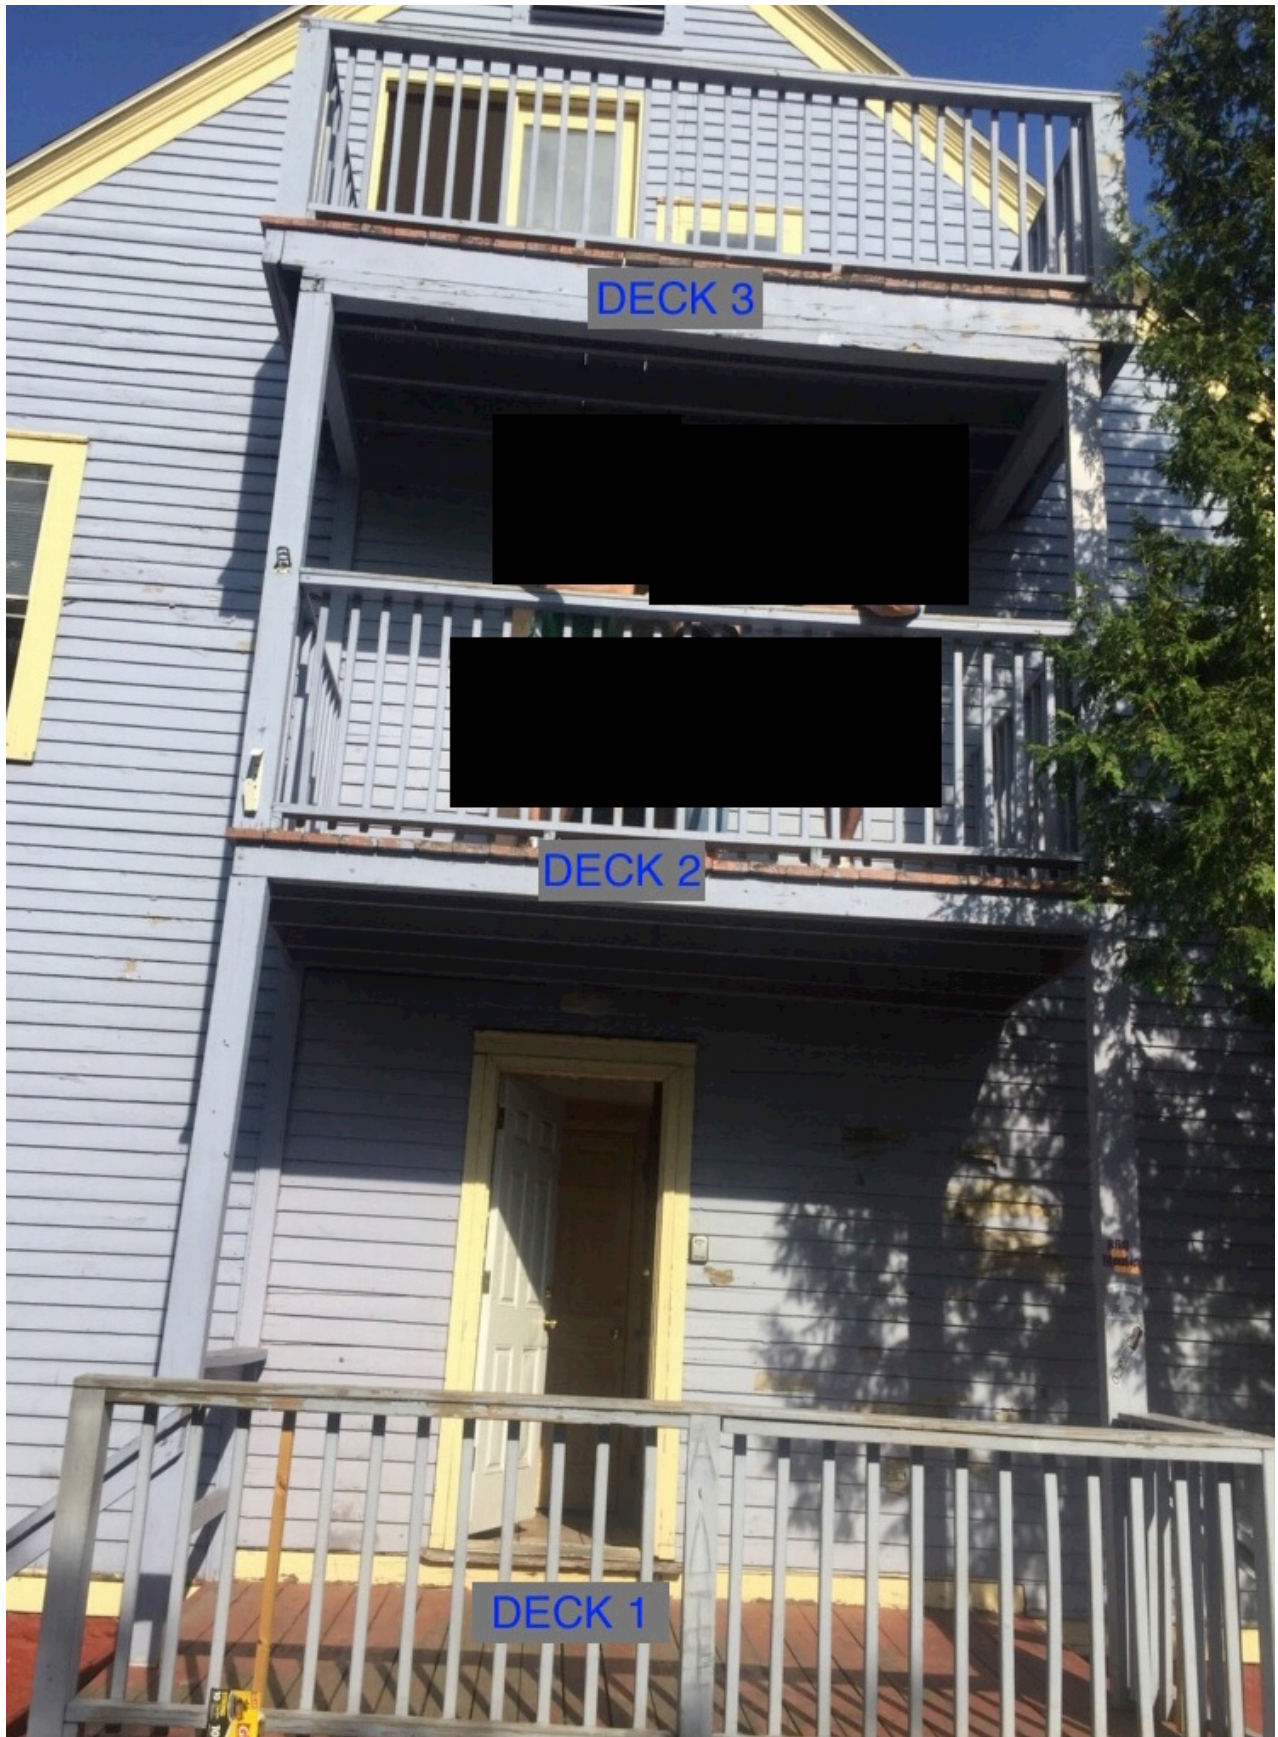
4. **DECK 3 BEAM DETERIORATION.** Deterioration of the Deck 3 beam frame was observed, primarily in the south beam. The first photograph in the appendix shows the deck intact prior to collapse and does not indicate any major section loss of these members. Compression of wood on the top surface of these members, however, and subsequent settling in the deck above would have been likely. Loss of deteriorated wood would have most likely occurred during the impact from the deck collapse.

**Decks Intact Prior to Failure**

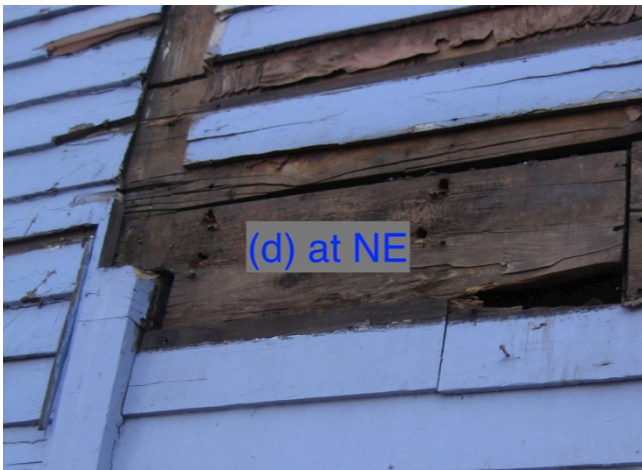
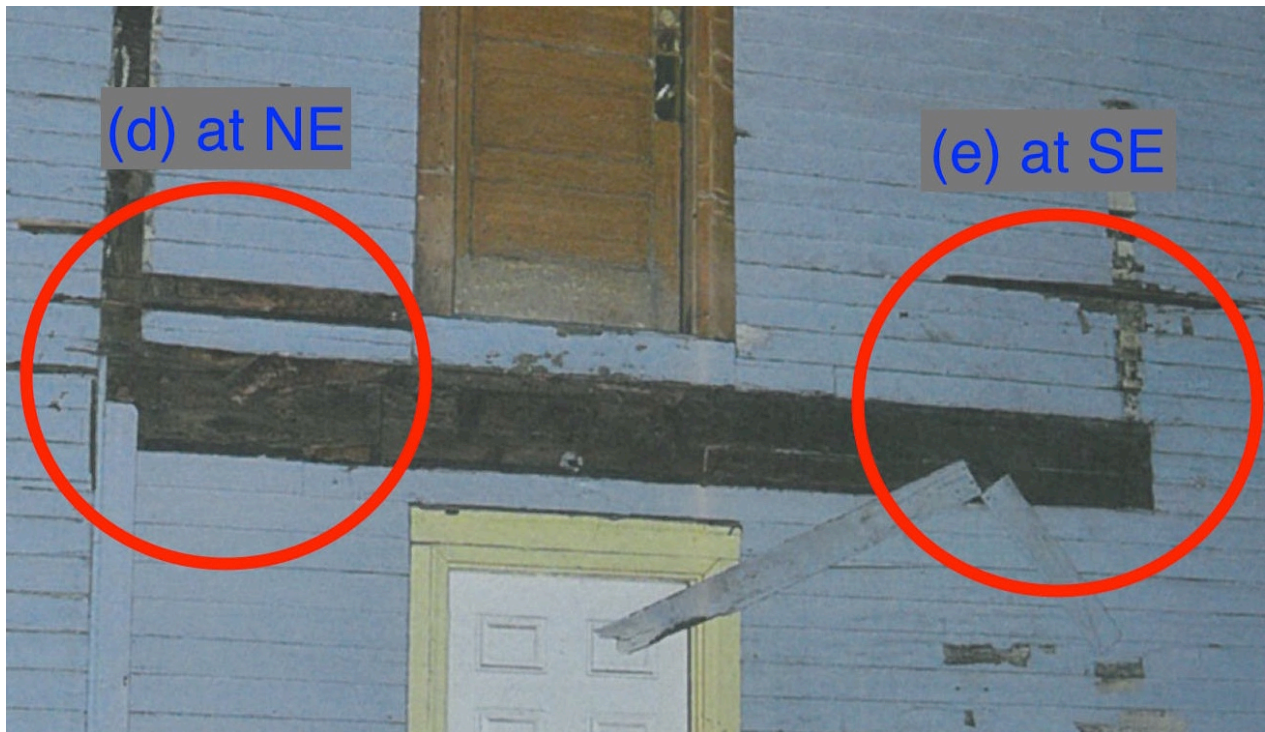
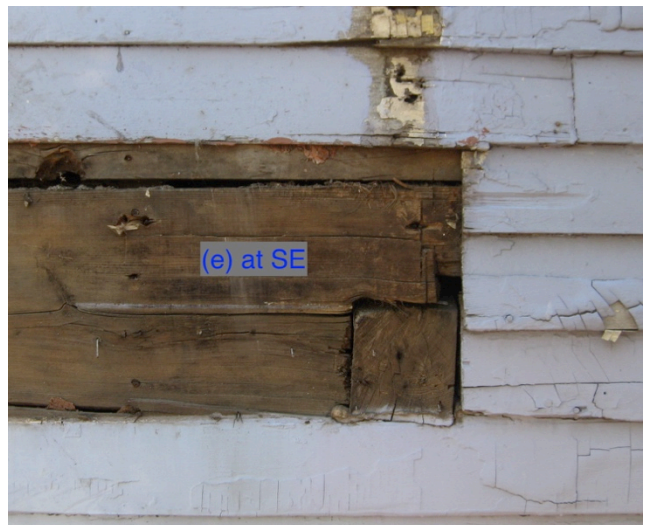
**Connection of Second Floor Deck to Main House (DECK 2)**

- (c) Second floor ledger along the house wall, *replacement* 2x6 mounted to *original* 2x6 with 2 rows of 4 nails with penetration limited to thickness of original ledger; *original* 2x6 mounted to main wall studs through the sheathing with (2) *original* nails per stud.

- (e) Second floor south-east (SE) corner, 2x6 beam nailed into end grain of original ledger with (2) nails, inclusion of vertical load resisting member or bearing not present as other corners, load transfer in this corner relies on indirect load transfer of nails from beam to ledger, then nailing from original ledger back to stud walls of the house.

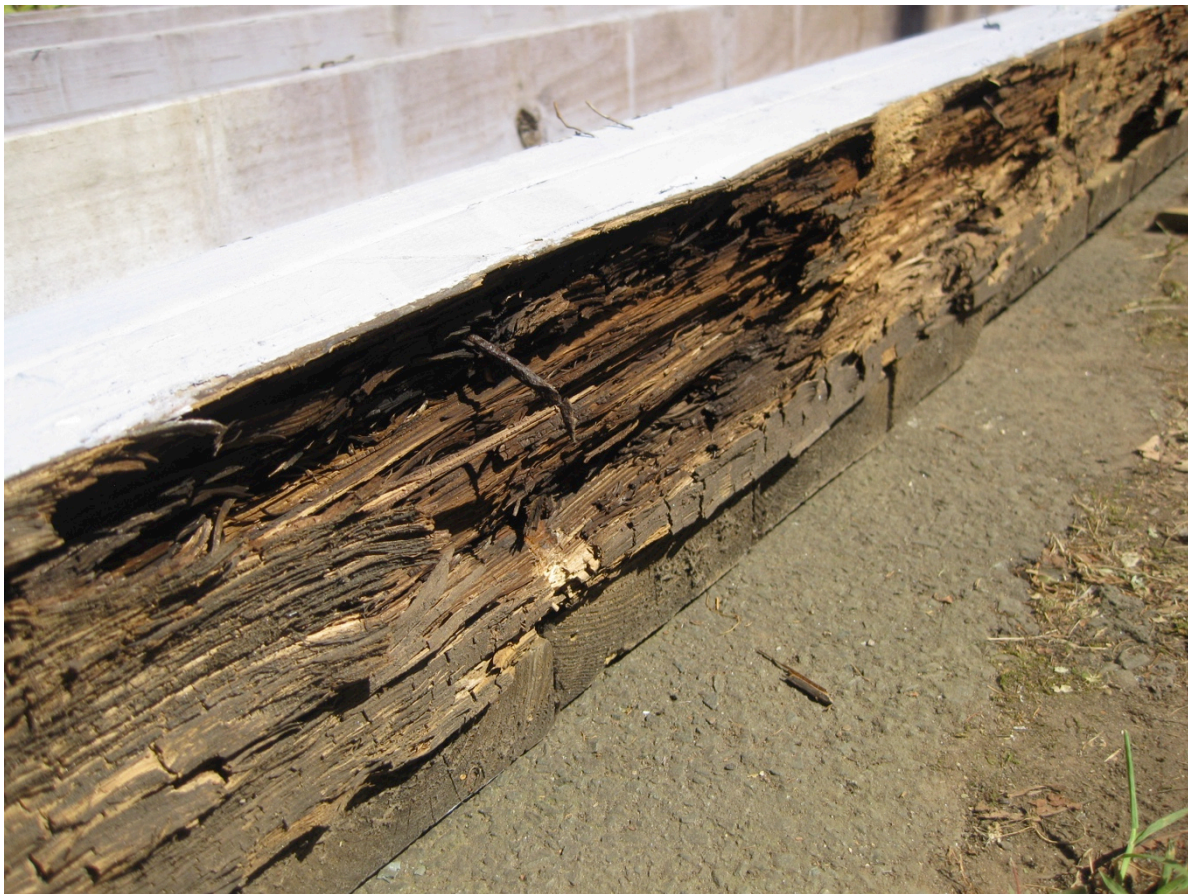
2. **DETERIORATION OF ORIGINAL 1925 LEDGER AND NAILS AT DECK 2.** A ledger is defined as the structural member in the plane of the deck framing located directly against and fastened to the main wall of the house onto which the deck is attached. At Deck 2 the original 1925 ledger was retained against the house onto which a new ledger was mounted. The original ledger was fastened to the main house studs with 2 nails per stud at 16" on center. The new ledger was mounted to the original ledger with 2 rows of 4 nails; the new nails did not penetrate through the original ledger to the studs; thus the replacement deck relied on the original 1925 ledger nails to transfer ledger loads back to the main house wall. The reconstructed deck did not include flashing over the ledger, a general best practice, to protect the ledger and fasteners from precipitation draining off the deck. As a result, the original 1925 ledger and its fasteners deteriorated and corroded over time, to the point of significant section loss and reduction of capacity.

**#2. Deteriorated Deck 2 original 1925 ledger and nails**

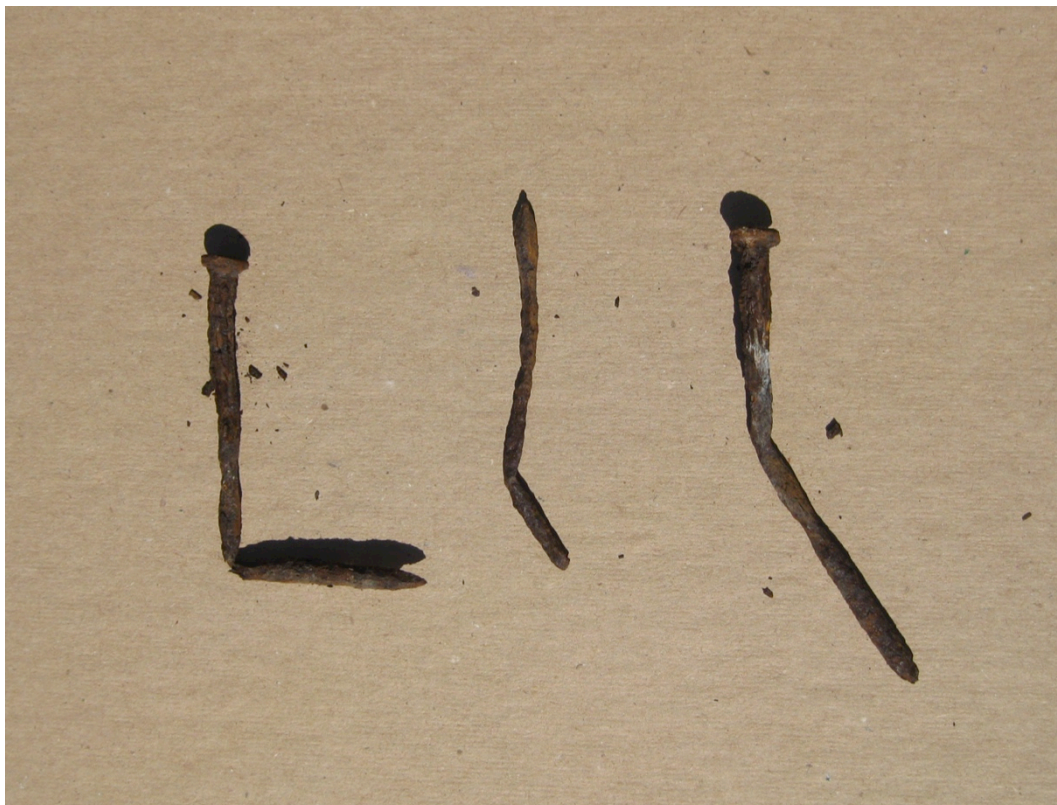
**#2. Corroded Deck 2 nails**

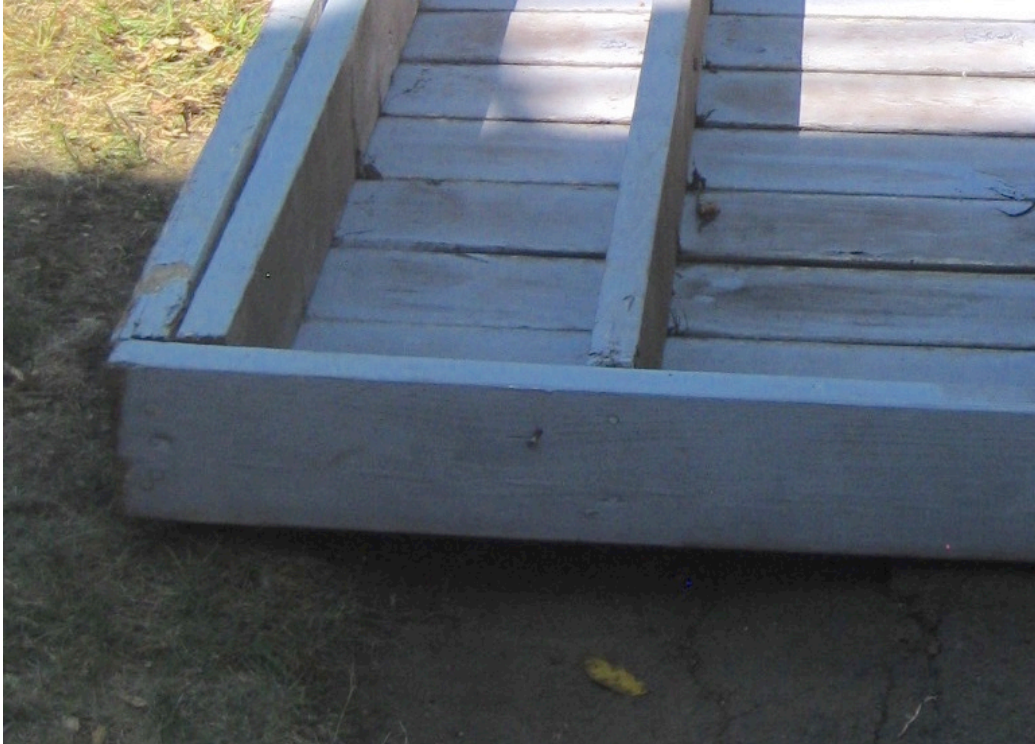
3. **LACK OF DIRECT SUPPORT FOR EAST END OF DECK 2 SOUTH BEAM.** Unlike the east end of the deck 2 north beam supported on the house wall by the 2x4 bracket post (d), or the deck 3 south beams supported by bearing into a pocket (k) in the house wall, the east end of the south beam was not directly supported by other structure. Rather, 2 nails were used to transfer loads from the beam into the end of the original 1925 ledger. As described in Item #2 above, the original ledger was supported by 2 nails into each stud. The nearest nailed ledger connection into the stud was approximately 12" north of the south-east corner. The size and quantity of nails was not adequate to support the loads from the beam end, especially with the 12" offset between the beam end and stud. In addition, severe corrosion on the ledger and nails undermined its capacity to support any load. Absence of a direct support for the east end of the beam is in direct violation of the code requirement for a continuous load path as described above.

It is our opinion that the deck failure was initiated at the south-east corner of the second floor deck where the edge beam was not directly bearing on the main wall of the house or a supplemental post as at other corners. Instead, sub-capacity nailing between the beam and ledger, and ledger and main wall studs, were supporting the beam end.

**#3. Deck 2 South-East Beam End Connected to Ledger with only 2 nails; SE beam end not extended to bear onto main house wall**

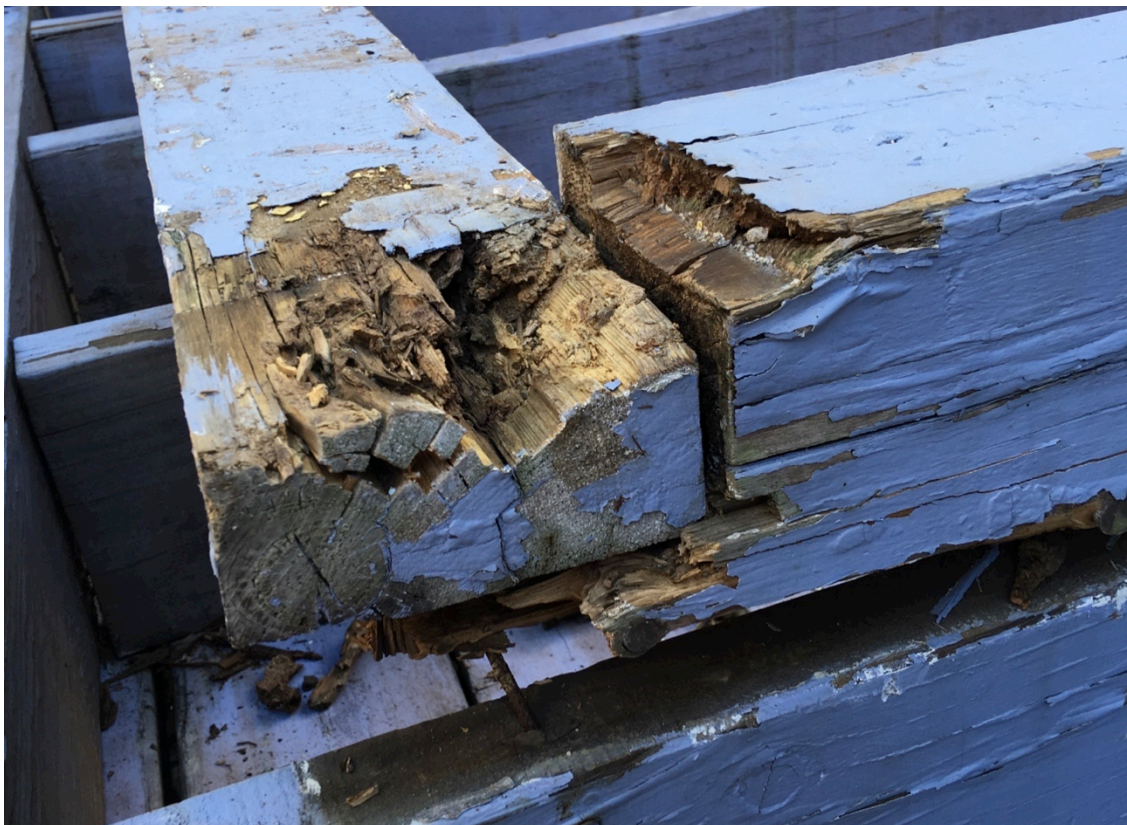
**#4. Deck 3 Deterioration at West End of South Beam**

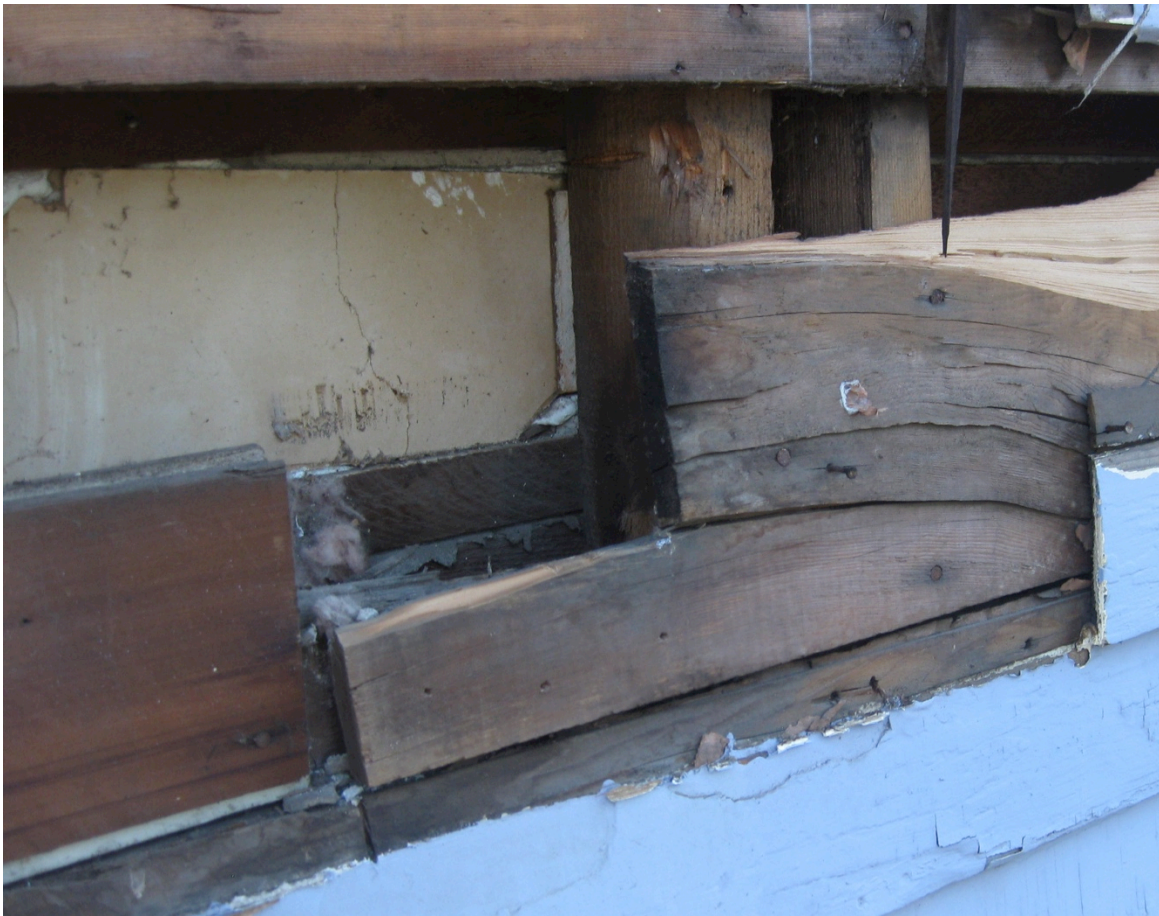
5. **MINIMAL BEARING AT DECK 3 SOUTH OUTRIGGER BEAM.** The deck 3 south outrigger was intended to bear on lumber blocking spanning between two main wall studs; however, hole in the sheathing for the outrigger did not quite align with the blocking; therefore, the bearing was supported entirely on the 1" nominal exterior sheathing of the main house. The bearing connection was not adequate to support minimum code-prescribed uniformly distributed live loads, and did not have the capacity to restrain the deck against lateral movements.

**#5. Deck 3, Wall Bearing Support at East End of South Beam**
