### Balcony Collapse Incident

Reference: 1713-1715 Broad Street - Deck Collapse Investigation

The following report presents our findings from the structural investigation of the collapse of the rear decks at 1713-1715 Broad Street in Hartford, Connecticut on September 10, 2016.

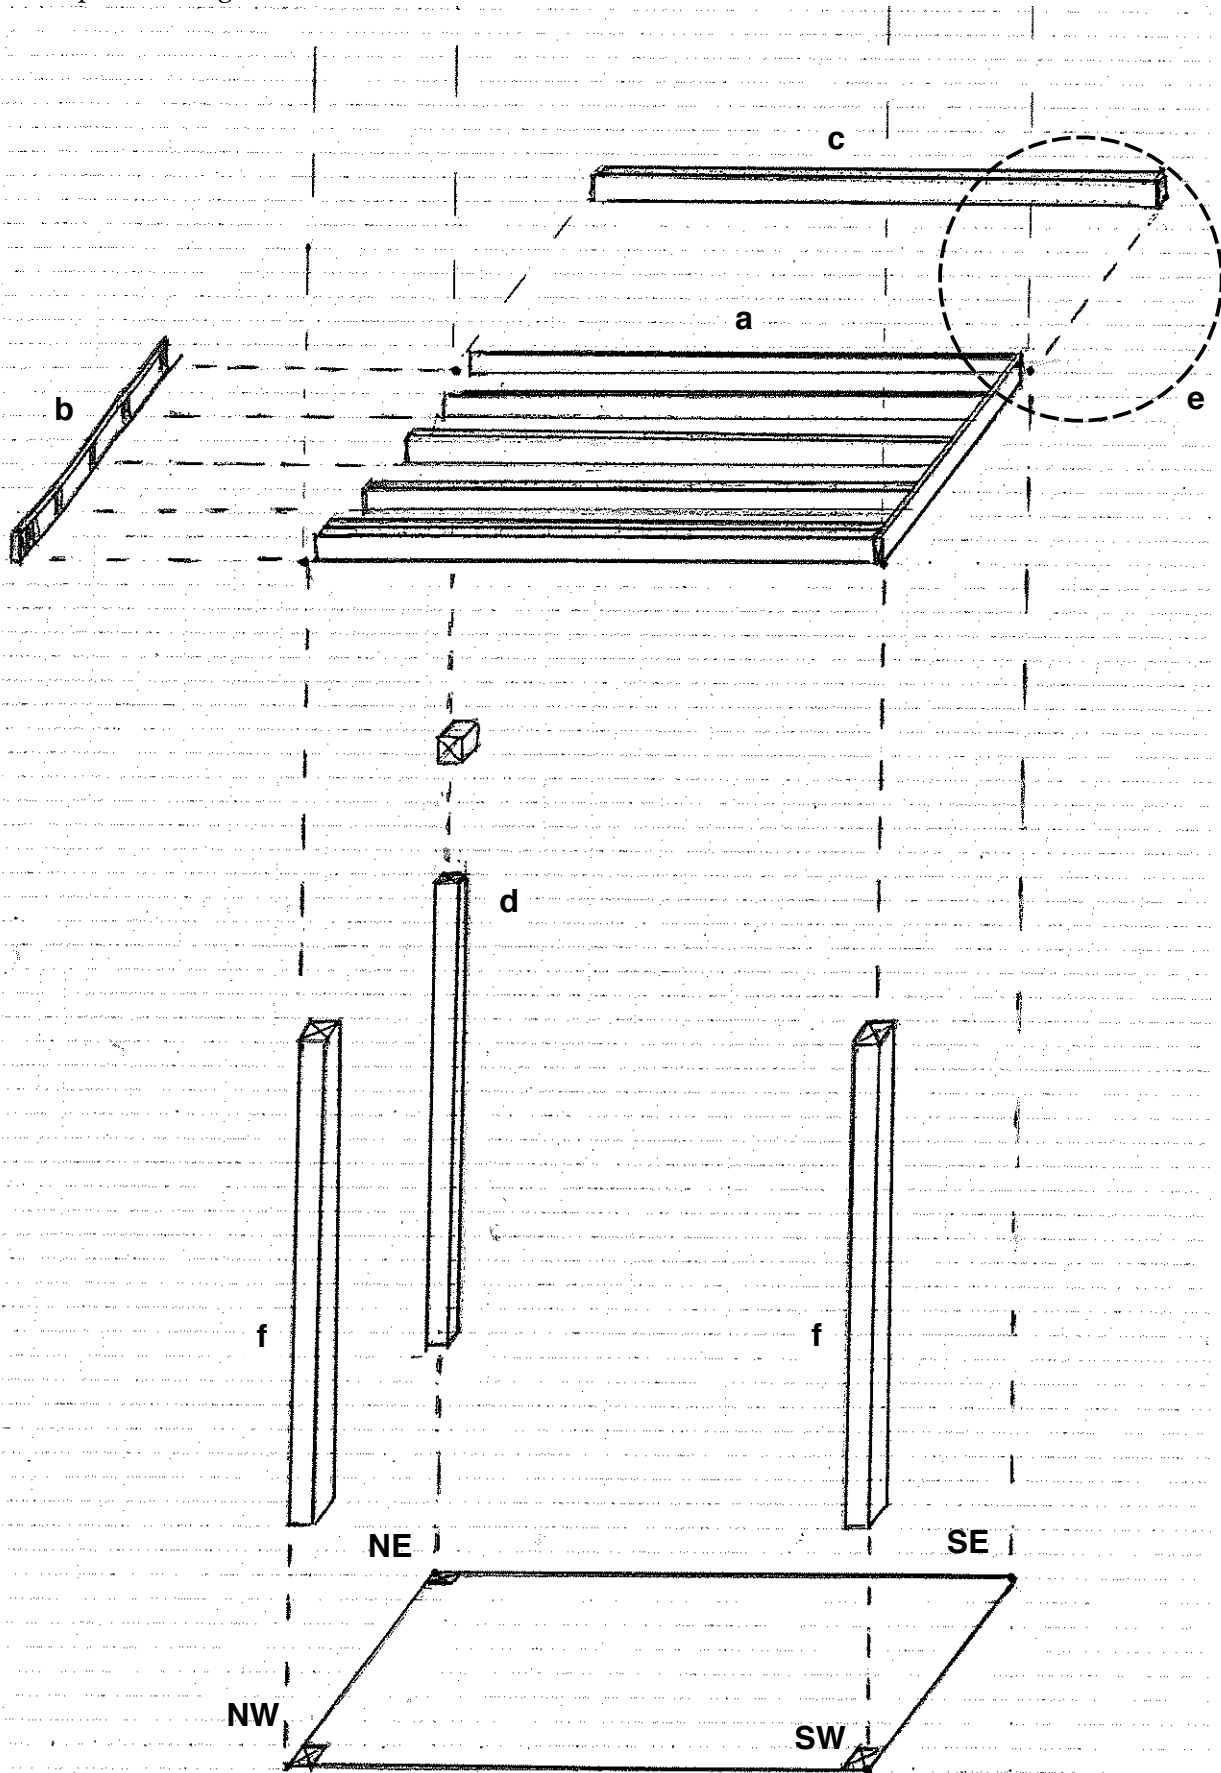
**Second Floor Deck Exploded Framing Sketch (DECK 2)**

Deck 2 – The deck framing for Deck 2 appears to have been completely rebuilt with the exception of the *original* 1925 ledger along the wall of the house onto which a new ledger was mounted. We observed abandoned original 4x4 outrigger beams cut-off at the main wall of the house. Deck 2 framing members include:

- (a) Decking on second floor joists, 2" nominal decking on 2x6 joists at 16" o.c., north-south spanning, *replacement*.
- (b) Second floor flush framed "beams", (1) 2x6, supporting joists on north and south ends of deck, east-west spanning, flush-framed with joists, *replacement*.
- (c) Second floor ledger along the house wall, *replacement* 2x6 mounted to *original* 2x6 with 2 rows of 4 nails with penetration limited to thickness of original ledger; *original* 2x6 mounted to main wall studs through the sheathing with (2) *original* nails per stud.
- (d) Second floor north-east (NE) vertical support, *replacement* 2x4 bracket post, original cut-off 4x4 outrigger beam visible and sandwiched in between ledger / beam connection and *replacement* 2x4 bracket post below.

- (e) Second floor south-east (SE) corner, 2x6 beam nailed into end grain of original ledger with (2) nails, inclusion of vertical load resisting member or bearing not present as other corners, load transfer in this corner relies on indirect load transfer through nails from beam to ledger, then nailing from original ledger back to stud walls of the house.
- (f) Second floor north-west (NW) and south-west (SW) vertical outer post supports, 4x6, *replacement*.
